NEWTON LOCAL LANDMARK REPORT

Staples-Craft-Wiswall Farm

1615 Beacon Street

**Prepared for:
Newton Historical
Commission
January 2015**

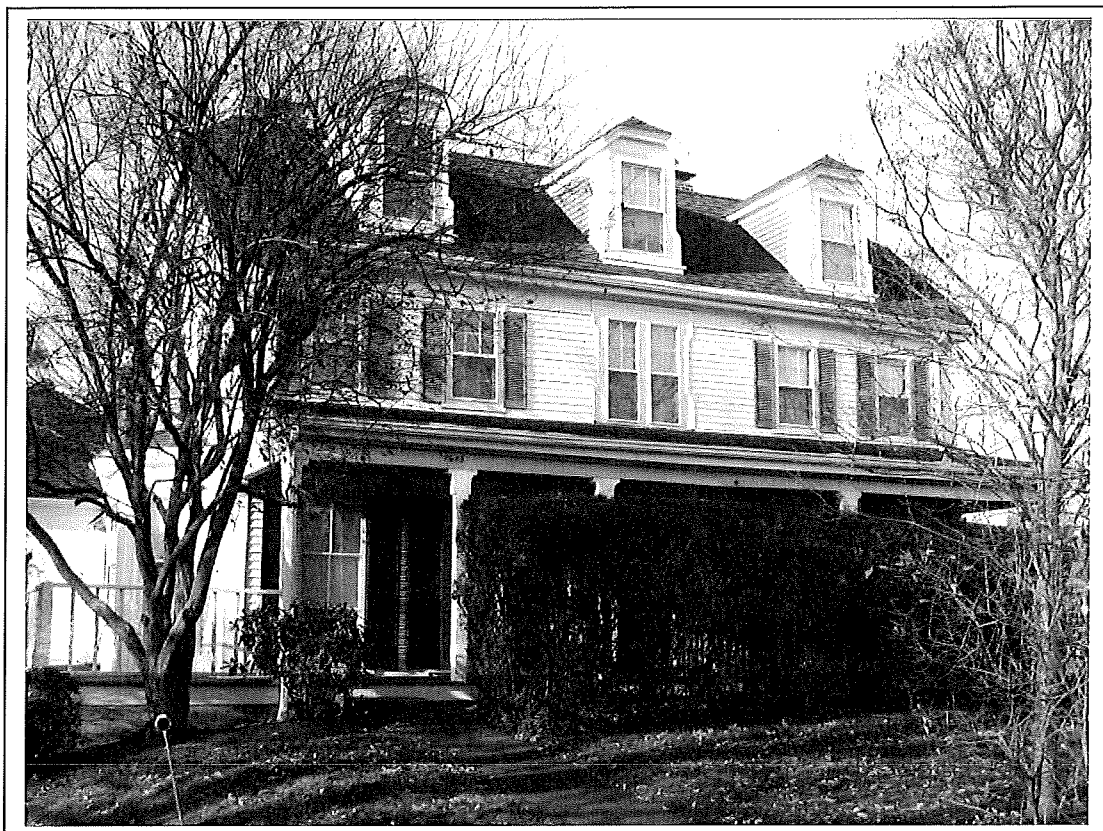
1615 Beacon Street, front façade, view from south to northeast

(2) *Verbal Description:* The building faces Beacon Street and is set close to the road. The front façade is five bays wide with six evenly spaced sash windows on the second story. Windows appear to have been originally 6/6 but are now false-muntin 6/6 replacements. Elongated 2/4 sash windows on the first story hang beneath a shed-roofed open veranda supported by a colonnade of squared columns with simple brackets. The central entrance is flanked by full sidelights and topped by a cornice with frieze, and what is now a veranda limited to the front façade reportedly at one time spanned all three sides of the house. A rear addition on the house that is visible from the west side was reportedly added c.1768, but recent additions have made this ell hard to discern from the exterior.

Three jerkinhead dormers (e.g. canted peaks) are symmetrically placed along the south-facing gable roof. Windows in each are replacement 1/1 sash windows, but the pilastered flared and beaded trim, a nod to early Tuscan architecture, appears to be original to a c.1860 alteration. This window trim is repeated on the central paired window on the second story of the front façade.

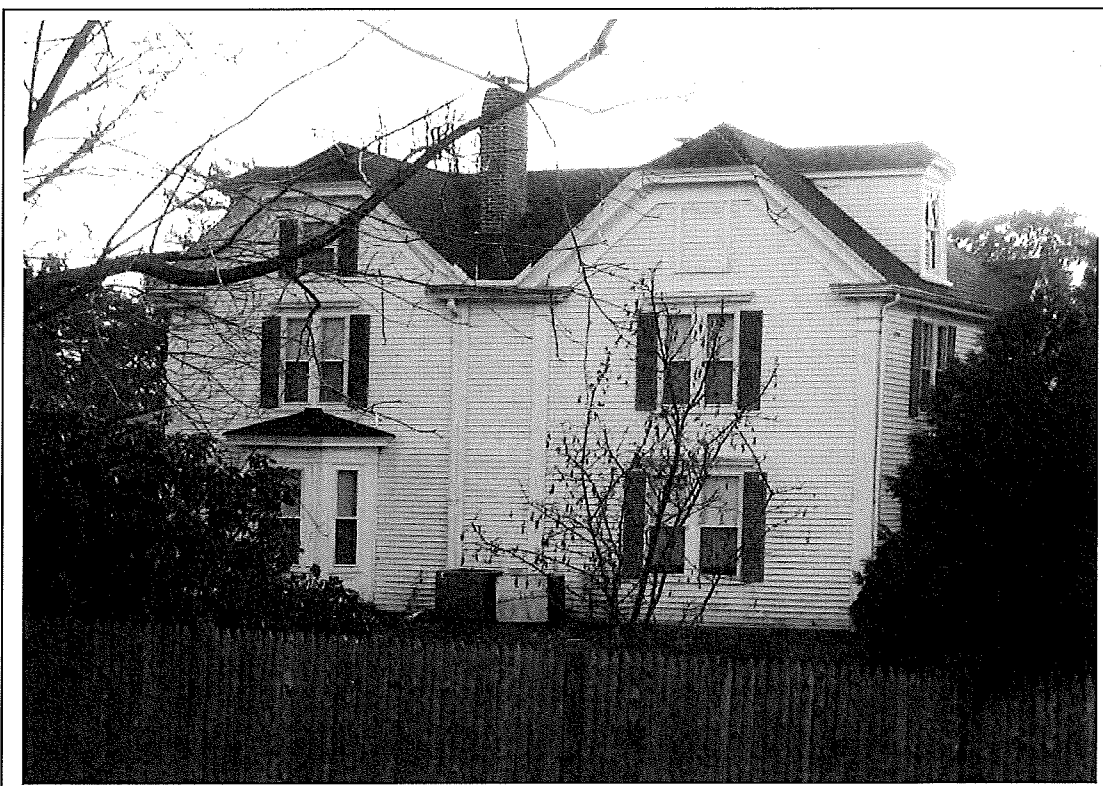
1615 Beacon Street, front façade, view from east looking west

The house is two bays deep on the west side, with a single sash window on the attic level, two sash windows on the second story and elongated sash windows beneath a hipped roof in a central bay on the first story. All windows on the west and east sides are topped by wooden, flat architrave hoods. The east side features two gabled vertical elements, the southernmost more narrow than the northernmost, separated by a windowless vertical panel with trim for a total of three bays. Both window bays have a central single sash window opening in the attic level; the window on the right bay has been removed. The second level features paired, elongated windows on both bays. A three-sided bay window with elongated sash windows and a hipped roof is centered on the left side; there is no bay on the right side, only paired sash windows that are larger than those on the second story.

All three east-side bays are framed with flat fascia boards. Pilastered corner boards with upper-edge beading frame the historic residence. The gabled roof has two interior plain brick chimneys, located on the west and east sides. The articulated roof trim on all four sides of the house has returns.
